# Super Lube Multipurpose Grease vs Petrolium based Lithium Grease

8 Months About 6,000hrs endurance test

(Feb.16, 2008~Oct.21, 2008: User inspection in Chiba Prefecture, Japan)

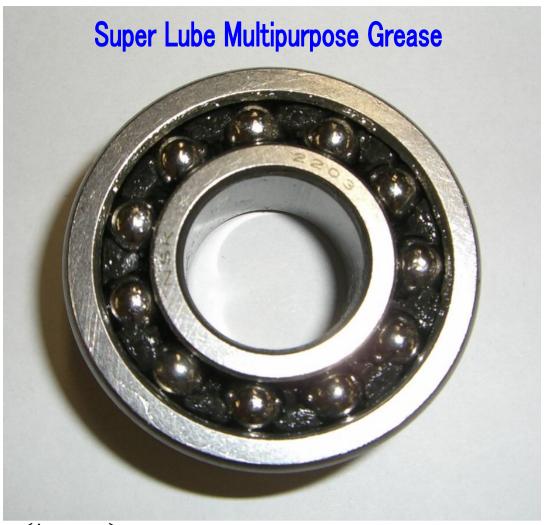
<Appearance>
Seems to be translucent and not found gummy or sludge material.

There was no hardening or softening, and the bearing rotated smoothly.

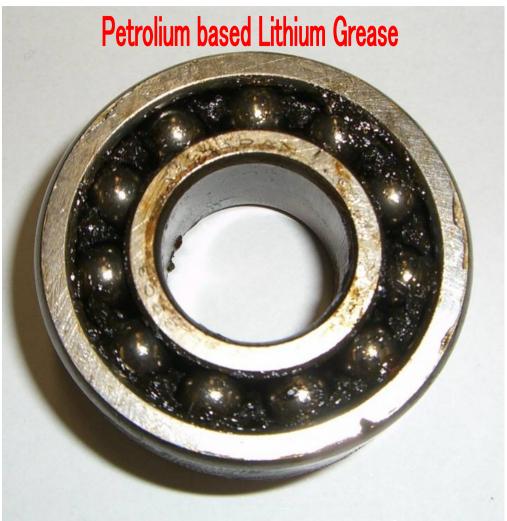
Very dirty at a glance with visible gumminess. Friction, contamination, and rust are visible.

The bearing suffered from hard rotation and seizing.

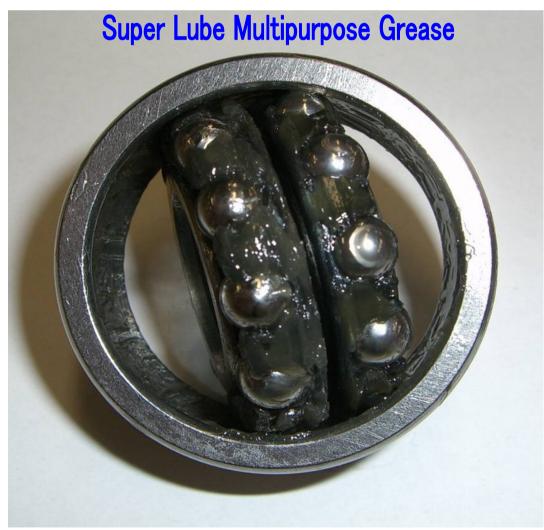
The ball seems translucent, beautiful, and the housing also does not seem to have any wear.

The bearing can rotate smoothly from the position in the upper picture to that of the lower picture.

Conclusion > Can be used due to no noise and smooth rotation.

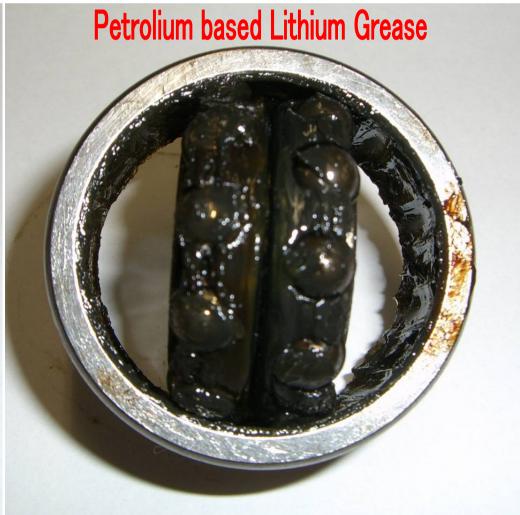
The ball is gummy, with some particles and wear. There are excessive amounts of sludge, and the housing is terrible.

This bearing suffered from friction and seizing. After moving it into the position in the lower picture, it was unable to return to the position found in the upper picture due to hard seizing.

Conclusion Need replacement (Noise generated)
